Air Velocity Distribution Behind Wing-Mounted Aircraft Engines

Transportation Development Centre

Transport Canada

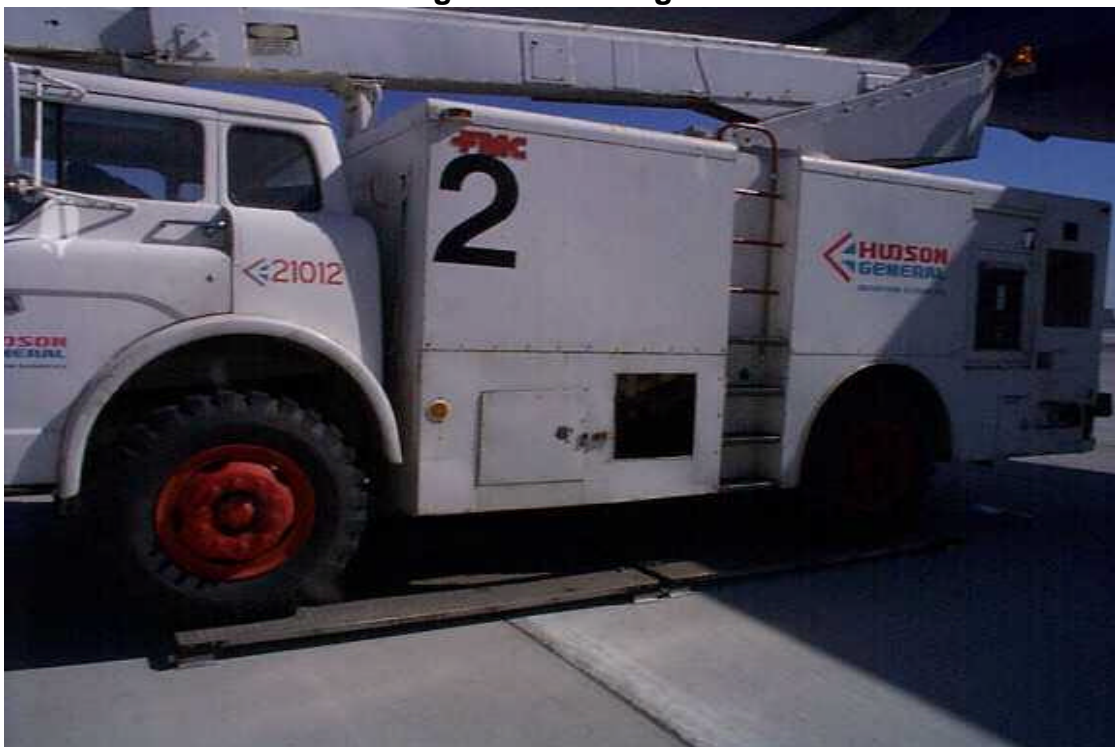
Photo 2.9
Deicing Truck on Weigh Scale

A deicing truck was positioned on portable weigh scales and subjected to the jet blast of an Airbus A310 engine at idle. The weight shift caused by the blast was used to calculate the overturning moment of the truck. A second method of moment calculation converted air velocity measurements to forces acting on the deicing truck.

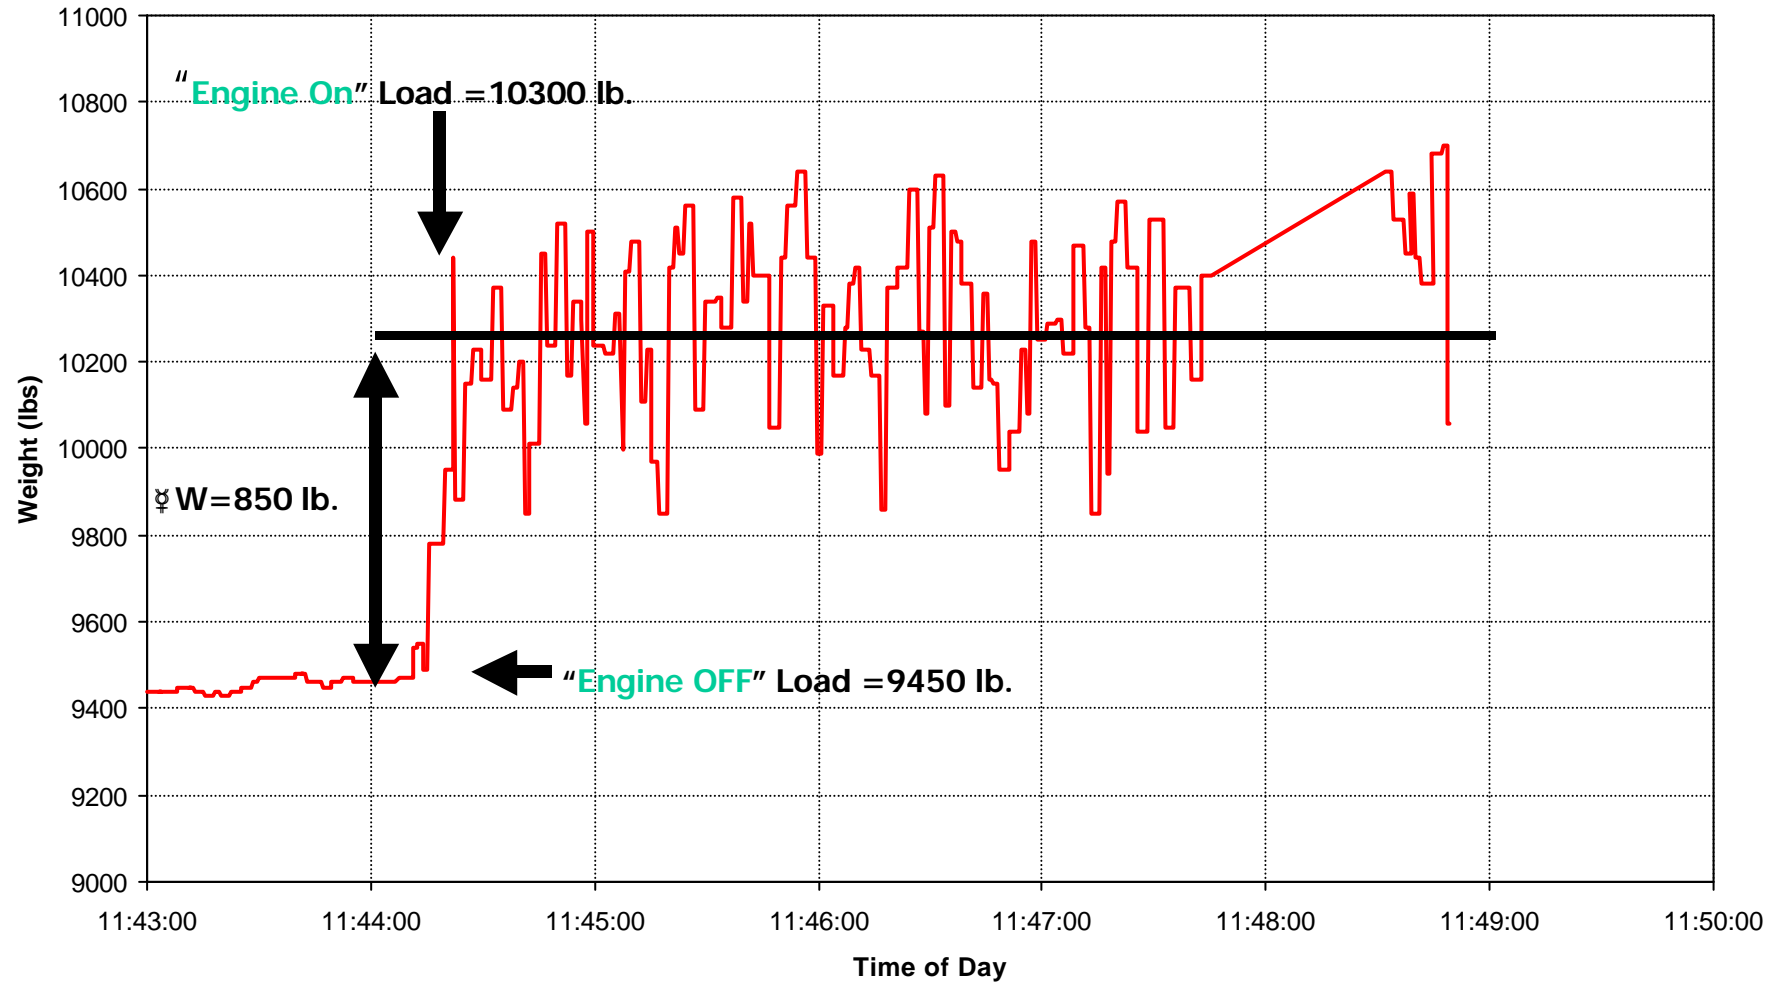
Figure 3.2
Weigh Scale Test Data

The data recorded from each weigh scale during the "engine on" period was plotted against real-time. The corresponding dead weight recorded from each weigh scale during the "engine off" period was then superimposed on the plot so that change in weight could be noted (Figure 3.2).

WIND VELOCITY - YYZ - WEIGH SCALE #1 (Rear, Leeward) March 23, 1999

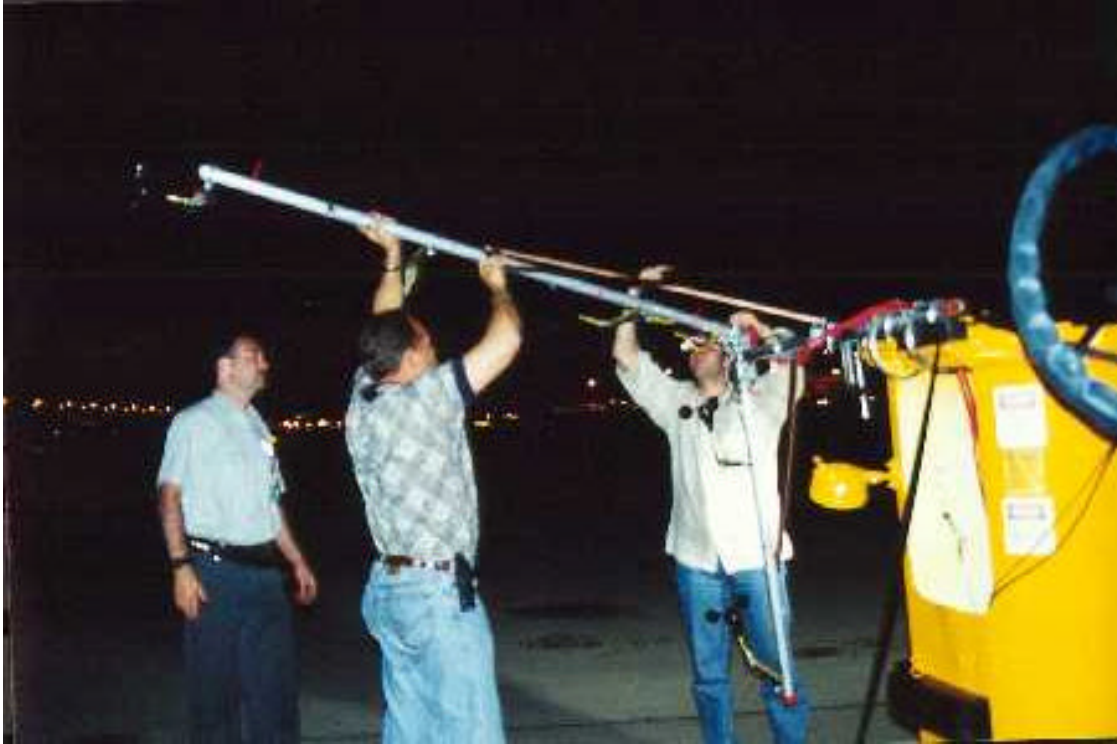
Photo 3.1
Anemometer Test Equipment and Deicing Bucket Damaged

Approximately two minutes of air velocity measurements were obtained. Equipment was damaged and became inoperable during testing. Emergency escape manoeuvres were implemented to avoid further damage or injury to personnel. A peak velocity of 190 km/h was recorded. The stability of the deicing truck during this test was affected by an overwhelming wave of air created by the aircraft engine, and the truck was considered unsafe.

One test was conducted on 5 May, 1999, on a runway at the Hartsfield Airport in Atlanta. The test was scheduled at night. Equipment outlined in Section 2.1.2 was used. Installation and verifications of functionality were part of a one-hour set-up process. The number of tests was limited by the flight schedule. Tests were discontinued due to permanent equipment damage caused by the first test. The jet blast of the engine at three-quarter throttle overwhelmed the structural integrity of equipment (Photo 3.1). Predetermined emergency escape manoeuvres were implemented to prevent further damage to the deicing truck and avoid injury to personnel.

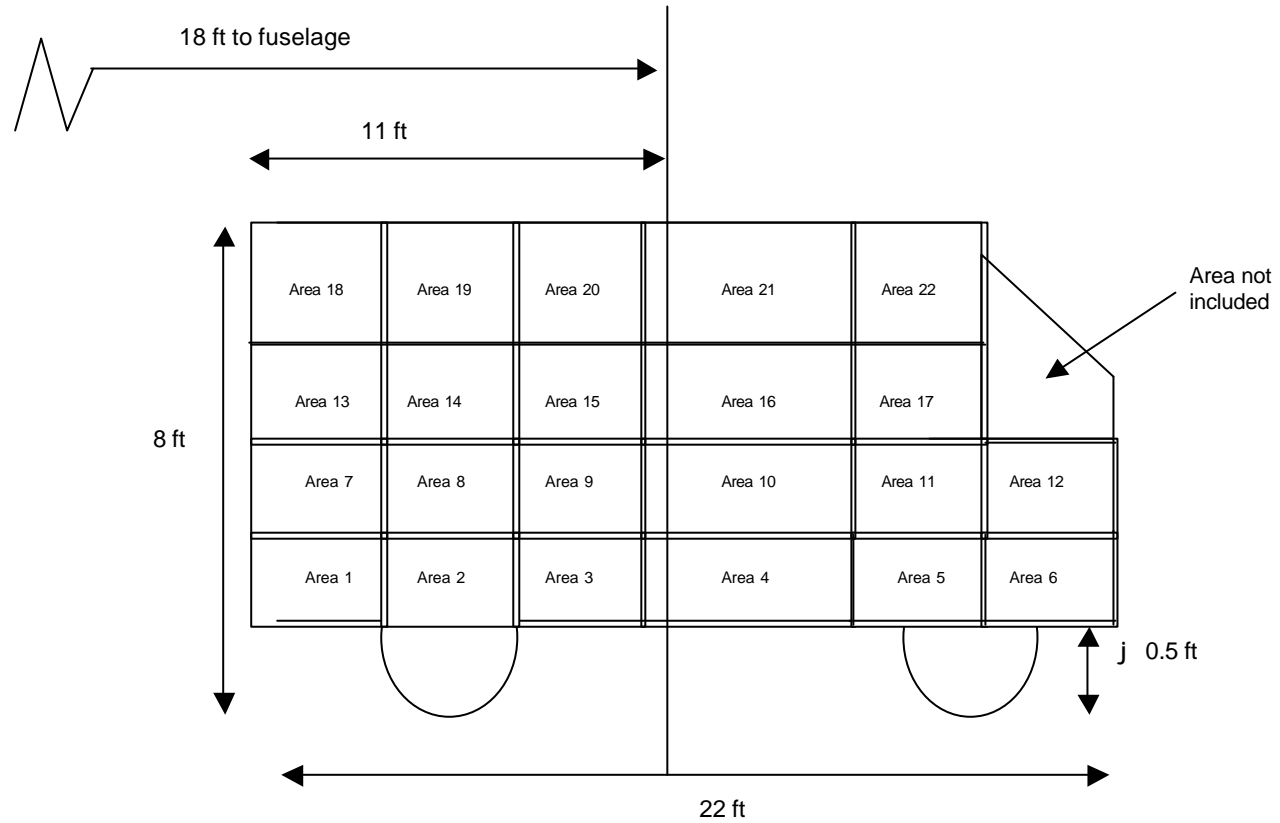
Figure 4.7
Tipping Moment Analysis

The Airbus A 310 used for this test recorded a peak air velocity of 160 km/h. The magnitude of the air velocity forces created by the A 310 thrust ranged from the order of 24 N to 2,300 N. These forces can be converted to moments acting on the truck. The overturning moment is calculated by using the forces for each quadrant, and the dead weight centroidal force of the truck, to calculate the moment about the long leeward axis of the truck at ground level. The total overturning moments exerted by the air velocity can then be shown as a percentage of the resisting moment caused by the dead weight centroidal force.

The total moments exerted by the thrust are approximately 10,700 Nm. The total moments about the leeward wheels of the truck, due to the weight, are 145,800 Nm. The moments exerted by the thrust are approximately 7.4% of the required moments to overturn the truck. It should be noted that the moment exerted is proportional to the square of the wind speed. Therefore, doubling the wind speed would quadruple the moment. Moreover, it is suspected that the distance away from the engine and the air velocities measured vary according to an exponential function. It has been stated that air velocities immediately at the exhaust of an aircraft engine are typically supersonic.

The direction of the jet blast relative to this diagram would be perpendicular and into the page.
